HOUSATONIC RIVER BASIN
DERBY, CONNECTICUT
LOWER ANSONIA RESERVOIR DAM
CT 00027

PHASE I INSPECTION REPORT
NATIONAL DAM INSPECTION PROGRAM

SEPTEMBER, 1980

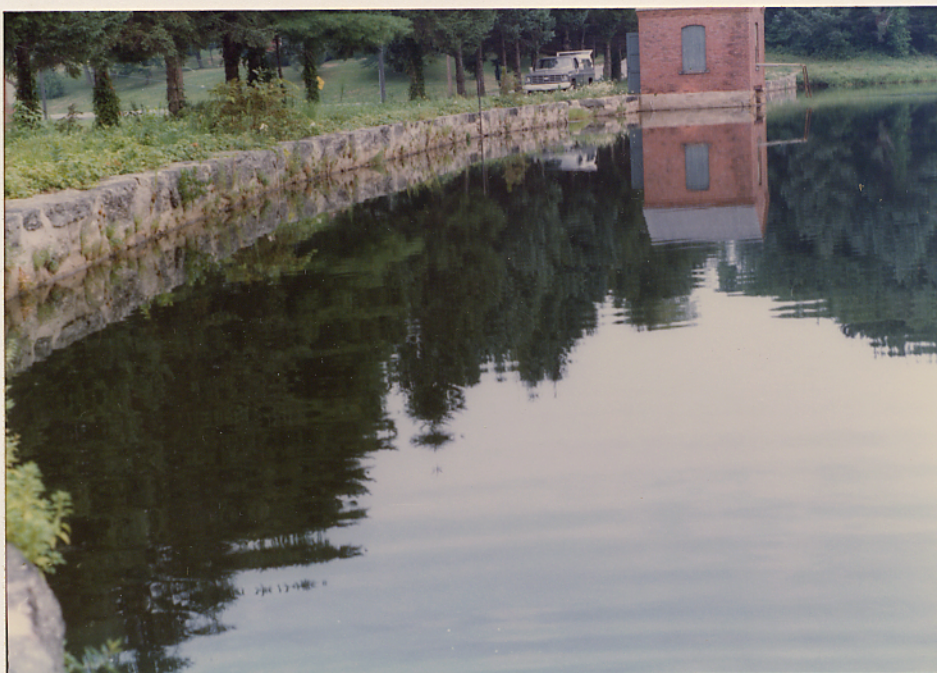
Top of Dam - The top of the dam is in fair condition. To the left of the spillway, it is covered with low weedy vegetation (Photo 1). Two small saplings near the upstream side were also noted. To the right of the spillway, the top of the dam is grass covered, with vehicle tracks evident. Along the downstream edge of the top of the dam is a row of pine trees. In some areas, pine needles cover the surface of the dam, choking the low vegetation on the dam. The top of the embankment appears to be uniform in elevation, at about the top of the upstream masonry wall. At the left end of the dam, where the wall ends, there appears to be a localized low area. This area is heavily overgrown, therefore its true configuration could not be positively ascertained.

Upstream Face - The masonry upstream face of the dam is in good condition with the stone blocks exhibiting almost no weathering. An inscription and a coin emplaced in the mortar indicate that the wall joints were repointed in 1969. The mortar joints are in fair condition with minor cracking and spalling noted. Weedy vegetation is growing from cracks in the mortar on the upstream face and top of the wall (Photo 1).

Photo 1 - Upstream face and top of dam viewed from left end (8/8/80).

5. Repointing of the cracked or leached mortar joints of the masonry walls and the brick gatehouse walls should be continued as part of the regular maintenance procedures at the dam.

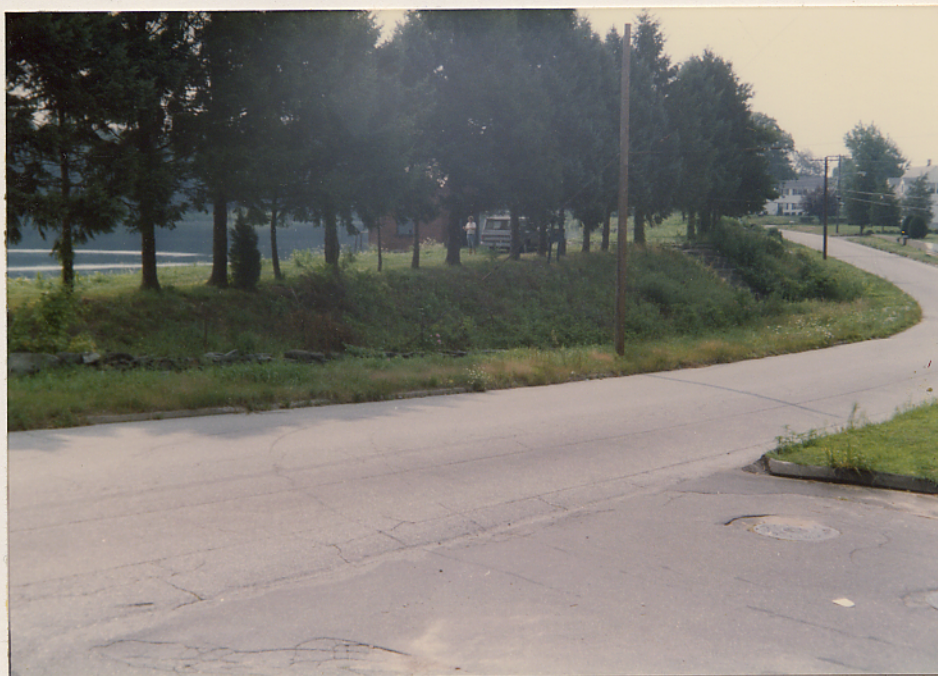
Downstream Slope - The downstream slope appears to be uniform in inclination and no evidence of sloughing or surface erosion was noted. However, much of the slope is heavily brush covered and difficult to inspect, especially to the left of the spillway (Photo 2, Overview Photo). A wet condition immediately to the left of the left spillway training wall is indicated by the presence of reeds and swamp grass in this area (Photo 3). This wet condition could be the result of surface runoff from the street along the toe of the dam and/or minor seepage through the dam. Vegetation is sparse in a few places on the downstream slope of the right side of the embankment, due to disposal of dead branches and grass cuttings on the slope. The dry laid stone wall and fence along the toe of the dam are in fair condition.

Photo 2 - Downstream slope and top of right side of dam (8/8/80).

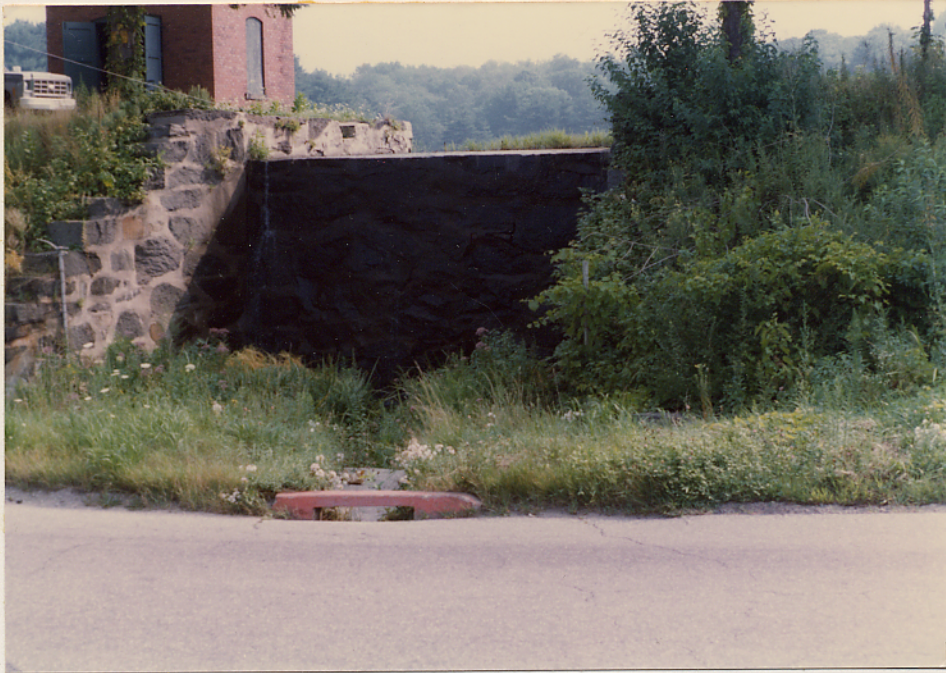
support of stop planks are located (Photo 4). The minor seepage from the spillway section noted in a 1971 inspection report (Appendix B-5) was not observable at the time of our inspection due to flow over the spillway. Riprap at the downstream toe of the spillway is small-sized and sparse. The spillway channel to the two 36 inch pipes under Academy Hill Road contains much vegetation and some debris (Photo 3), and approximately 75% of the cross-sectional area of one of the 36 inch pipes is filled with debris.

Photo 3 - Downstream face of spillway and spillway discharge channel (8/8/80).

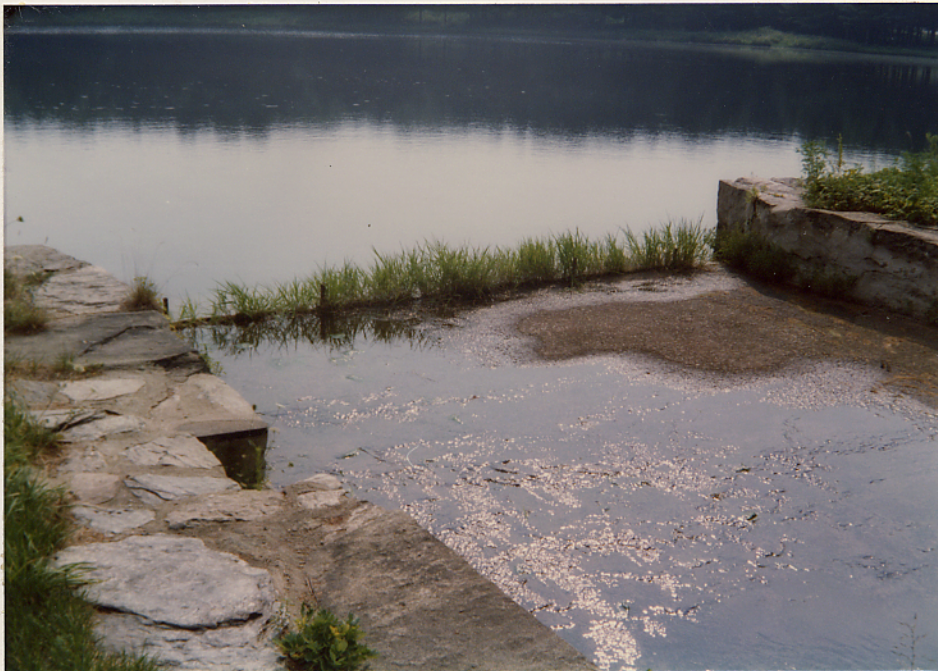
Spillway - The masonry spillway section appears to be in good condition. Minor cracking of the mortar joints of the training walls was noted. No deterioration of the concrete cap on the spillway crest was observed. There is some grass growing near the upstream end of the spillway crest, where steel stanchions for

Photo 4 - Spillway crest (8/8/80).

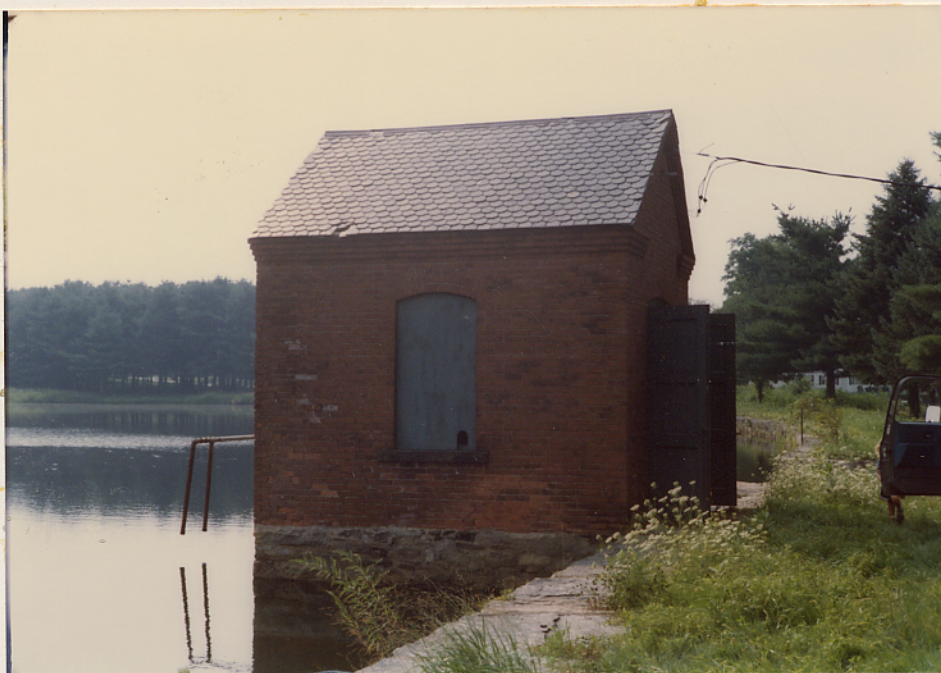
c. Appurtenant Structures - The gatehouse, intake chamber, and operating facilities appear to be in good condition. Some areas of the masonry substructure were resurfaced with mortar which does not exhibit any cracking or spalling. Leaching of some of the mortar joints of the superstructure brickwork and deterioration of a few bricks was noted (Photo 5). The operating facilities for the supply main and the intake chamber drain pipe appeared to be well lubricated and are operable (Photo 6). The gate screens and the steel brackets in which they slide are in poor condition, exhibiting considerable corrosion. The wood deck over the intake chamber is in good condition. The gate valve stem for the low-level outlet, located 35 feet to the left of the spillway, is corroded. The owner reports that the handle for this gate valve is kept in the gatehouse and that the gate is operable.

Photo 5 - Gatehouse (8/8/80).

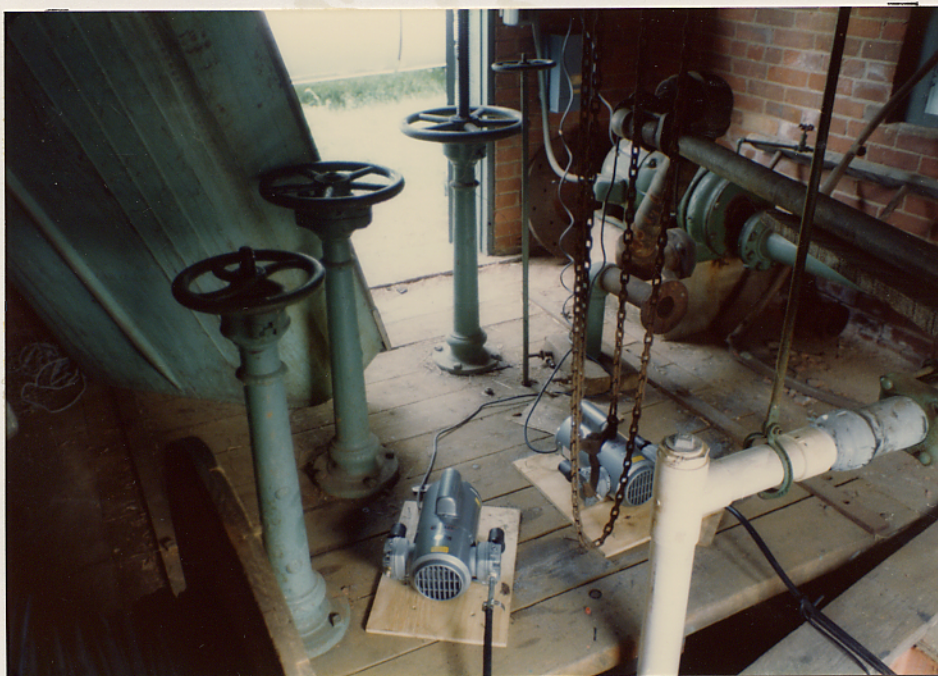
Photo 6 - Interior of gatehouse (8/8/80).

7. The intake chamber screens and the low-level outlet valve stem should be treated to protect them from further corrosion.
8. Reported seepage through the spillway and embankment should be monitored.
